ROAD SAFETY AUDIT

Blue Hill Avenue (Route 28) and Warren Street
High Crash Locations

City of Boston

November 1, 2016

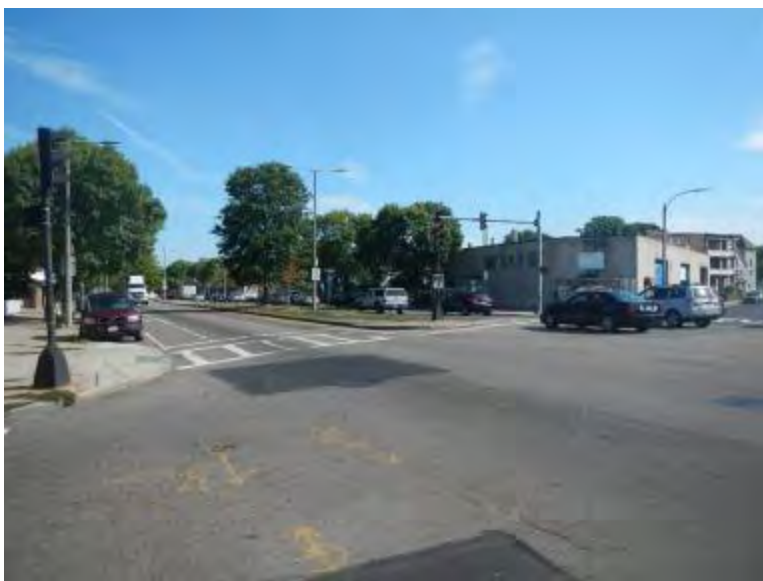
Blue Hill Avenue, Baird Street and Woodrow Avenue form a four-legged intersection under traffic signal control. Woodrow Avenue is classified as an Urban Collector, while Baird Street is a local road. All roadways are under City jurisdiction. Blue Hill Avenue is a median-divided boulevard-style roadway.

Blue Hill Avenue carries three travel lanes north from Morton Street towards Baird Street and Woodrow Street, as well as a marked bike lane and a parking lane. The dedicated bike lane ends approximately 130 feet in advance of the intersection, and shared accommodation for bicycles is provided within the outside travel lane approaching the northbound stop line. The outside travel lane has constrained width at the stop line due to the curb extension on the southeast corner of the intersection, and does not continue beyond the intersection, requiring northbound through vehicles utilizing this lane to merge within the intersection.

The southbound Blue Hill Avenue approach provides two travel lanes, a bike lane, and a parking lane. The travel lanes and bike lane are continuous on the departure side of the intersection. No exclusive turn lanes are provided on Blue Hill Avenue at Baird Street and Woodrow Avenue, and turning movements are accommodated from shared lanes. Baird Street provides one-way westbound travel departing the intersection, with parking allowed on both sides of the roadway. Woodrow Avenue provides two-way travel with adjacent parking, although no lane markings are provided.

**Blue Hill Avenue at Baird St/Woodrow Ave
(looking north)**

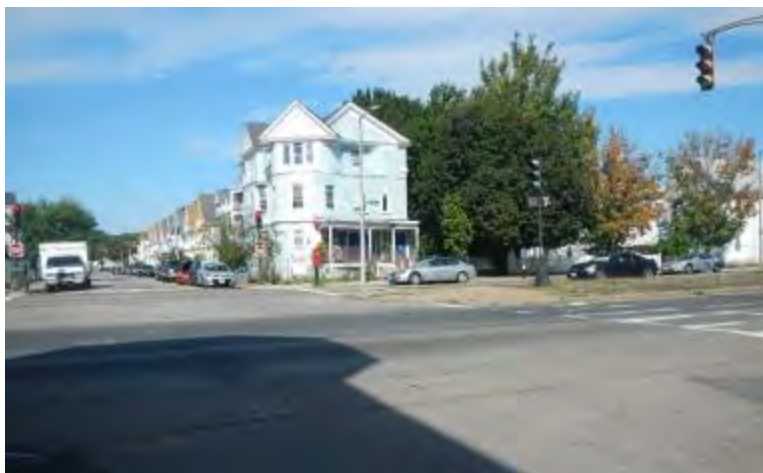
Blue Hill Avenue, Balsam Street and Johnston Road form a four-legged intersection under traffic signal control. Blue Hill Avenue continues as a median-divided boulevard-style roadway through its intersection with Balsam Street and Johnston Road, which are both classified as local roads.

Blue Hill Avenue provides two travel lanes in each direction through the intersection, along with a marked bike lane and a parking lane. Balsam Street and Johnston Road are both one-way roadways approaching Blue Hill Avenue; as such, no turns are made from Blue Hill Avenue. Balsam Street and Johnston Road both provide a single travel lane approaching the intersection, with parking allowed on both sides of the roadway.

**Blue Hill Avenue at Balsam St/Johnston Rd
(looking west)**

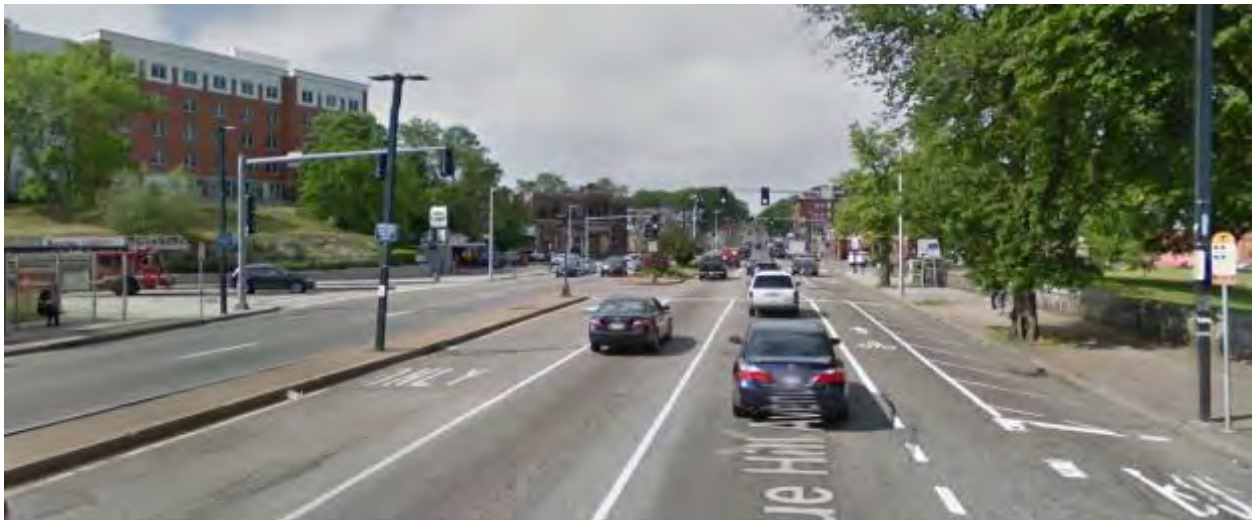
Blue Hill Avenue, Harvard Street and Talbot Avenue form a complex intersection under traffic signal control. The intersection is comprised of two offset intersections with Blue Hill Avenue forming the north-south leg of both intersections. Blue Hill Avenue continues as a median-divided boulevard-style roadway through the intersection. Harvard Street intersects from the west at the southern intersection and Talbot Avenue and Harvard Street intersect Blue Hill Avenue at the northern intersection from the southeast and northeast, respectively. Harvard Street and Talbot Avenue are both classified as Urban Minor Arterials under City of Boston jurisdiction.

**Blue Hill Avenue at Harvard Street and Talbot Avenue
(looking north)**

Blue Hill Avenue northbound provides a left turn lane and two through lanes approaching the southern intersection of Harvard Street. The two through lanes and an adjacent bike lane continue through both intersections. A northbound right turn lane for turns to both Talbot Avenue and the eastern leg of Harvard Street begins immediately north of the southern intersection; however, vehicles were observed using the bus stop and shoulder approaching the intersection to bypass queued vehicles and access the right turn lane.

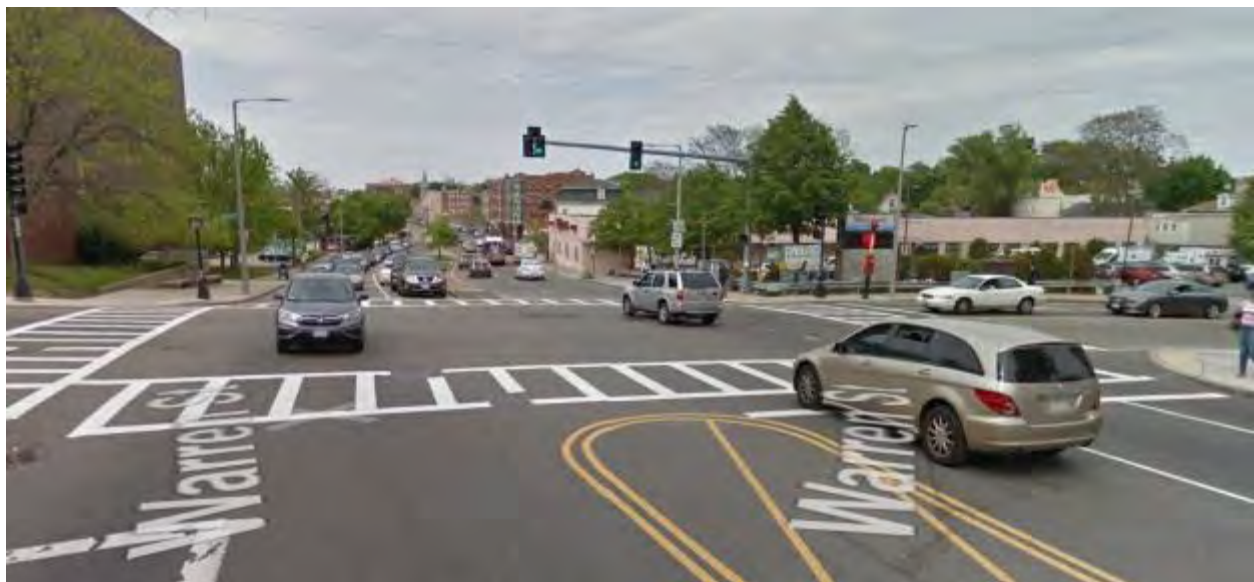
Warren Street, Quincy Street and Townsend Street form a four-legged intersection under traffic signal control. All three streets are Urban Minor Arterials under City of Boston jurisdiction.

Warren Street changes character in the vicinity of this intersection. Warren Street from Blue Hill Avenue north to Quincy Street and Townsend Street provides a single travel lane in each direction, divided by a double yellow centerline. Warren Street north of the intersection to Dudley Square provides two travel lanes in each direction divided by a cement concrete or planted median. The Warren Street northbound approach to Quincy Street and Townsend Street expands to a three lane approach, with a left turn lane and two through lanes. Shared accommodation for bicyclists is provided in the right travel lane, which immediately abuts the curb and has an adjacent bus stop. These factors may cause confusion amongst drivers who may not realize that this is a through travel lane. The southbound Warren Street approach provides a left turn lane and a wide through lane with shared accommodation for bicyclists.

**Warren Street at Quincy Street and Townsend Street
(looking north)**

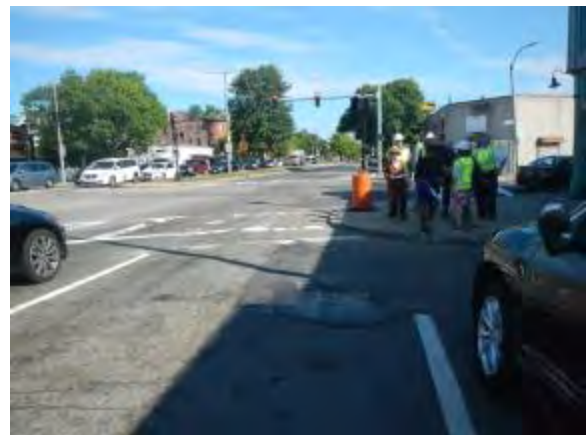
- Northbound Lane Alignment – The northbound approach provides three through lanes, with the right-most through lane having constrained width due to the curb extension. It was also noted that this third lane does not continue through the intersection, requiring vehicles to merge within the intersection. The location of the curb extension

Curb Extension constrains right through lane

may be a factor in two crashes where a vehicle struck the signal post on the southeast corner, while the lack of a receiving lane is a likely factor in fixed object crashes on the northeast corner of the intersection.

- Revise northbound lane alignment approaching Baird Street and Woodrow Avenue. The right through lane heading northbound is presently constrained by the curb extension, and the three lane section is not continuous through the intersection. Furthermore, the bike lane ends in advance of the intersection, with shared accommodation provided within the three lane approach. It is recommended to transition to a two lane section on the northbound approach and maintain a continuous bike lane approaching the intersection. This is a short-term, low cost improvement that can be accomplished with pavement markings but will be further formalized in conjunction with curb and sidewalk reconstruction as part of the planned project.

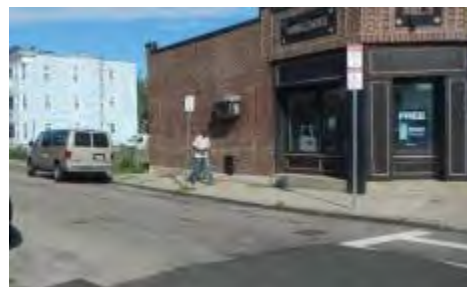
- **Parking** – It was noted that the defined limits of parking areas may be too close to the intersection, which may be a contributing factor in five crashes involving parked cars. It was also suggested that vehicles park outside of the defined limits. Audit participants specifically focused on the handicap parking space established on the north side of Baird Street. This zone begins less than 10 feet beyond the crosswalk, in violation of the Manual on Uniform Traffic Control Devices (MUTCD), which requires 20 feet between a crosswalk and the beginning or end of a parking zone. It was also noted that a delivery driver for a nearby pizza shop regularly parks partially within or behind this handicap zone, resulting in even further encroachment on the intersection.

Handicap Parking Zone close to crosswalk

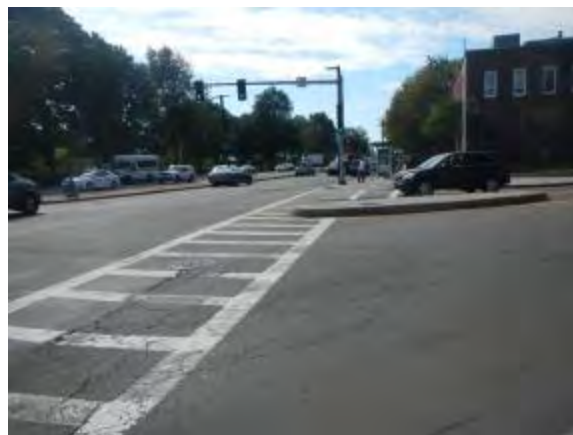
- Pedestrian Accommodations – Several items related to pedestrian accommodations were noted as safety issues.
 - Pedestrian signal heads do not provide countdown intervals.
 - Pedestrian intervals are not long enough to meet current standards. The intersection is designed for single stage crossings of each leg of the intersection, but the length of the pedestrian interval may cause pedestrians to cross in two stages.
 - The nose of the island on the north leg of Blue Hill Avenue and on the west leg of Harvard Street partially blocks the crosswalk. Ramps

Island nose partially blocks crosswalk

- are not provided to allow access to the island, although a pedestrian pushbutton is provided for the Blue Hill Avenue leg.
- Pedestrians crossing multiple legs of the intersection must wait through multiple cycles to utilize the exclusive pedestrian phase for each crossing stage of their intended path. This can take up to five minutes given the signal cycle length. While only one crash was recorded involving pedestrians, this condition could lead to impatience amongst pedestrians and could encourage pedestrians to choose to cross without the WALK signal.

- As noted above, the island on the west leg of Harvard Street partially blocks the crosswalk. This island also lacks signage or other vertical elements and may not be clearly visible to drivers, which may be contributing factors in angle crashes where northbound turning vehicles strike the island.

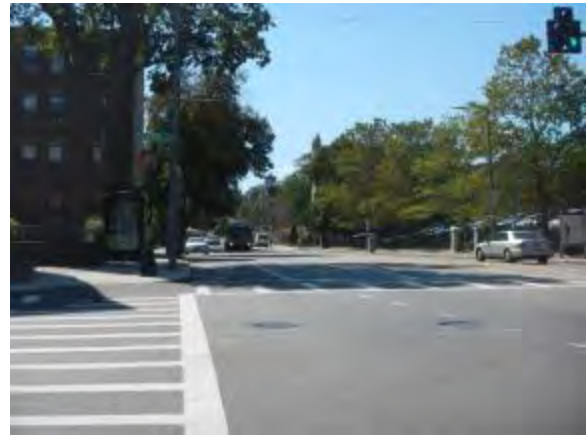
Southbound Lane Trap

- Southbound Lane Trap – Warren Street southbound provides two travel lanes, with the left lane becoming a left turn lane at the intersection. An R3-7L “Left Lane Must Turn Left” sign and arrow and “ONLY” pavement markings are provided; however, three sideswipe crashes suggest driver confusion over intended lane assignments.
- Queueing – It was noted by audit participants that southbound queues sometimes extend back to Martin Luther King, Jr. Boulevard, a distance of approximately 530 feet. Traffic congestion can lead to driver frustration and can be a factor in both rear-end and angle crashes at the intersection.

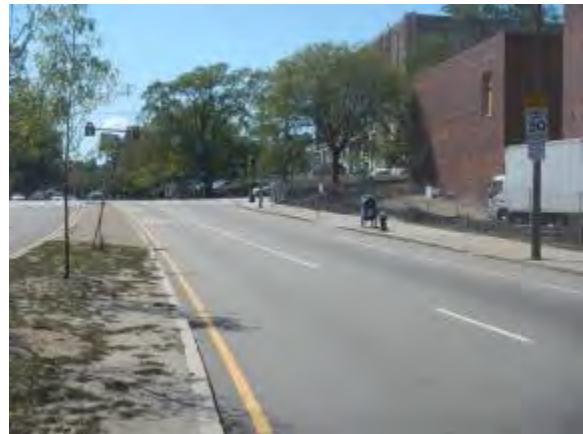
- Northbound Lane Configuration – The northbound approach provides a left turn lane and two through lanes; however, the right through lane is immediately adjacent to the curb and is narrow, and may appear to be a parking lane. Further exacerbating this issue is a bus shelter and bus stop established within the lane, and a “sharrow” marking indicating shared accommodation for bicycles. Drivers may assume that this is a bus stop and/or a bike lane and not a lane for vehicles, although dotted markings through the intersection suggest a continuation of the lane as a through lane on the northbound departure side of the intersection.

**Northbound lane approach
with bus stop**
